Pavement Condition Report

Madison Municipal Airport

Project 16801839

January 2016

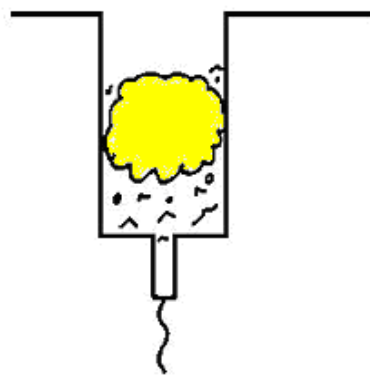
Typical failed joint sealant, w/ debris and incompressibles.
