Managing Risk – Balancing Design Criteria with Site Constraints

James Emerick, P.E. – INDOT Hydraulics

Jordan Bosse, P.E. – American Structurepoint

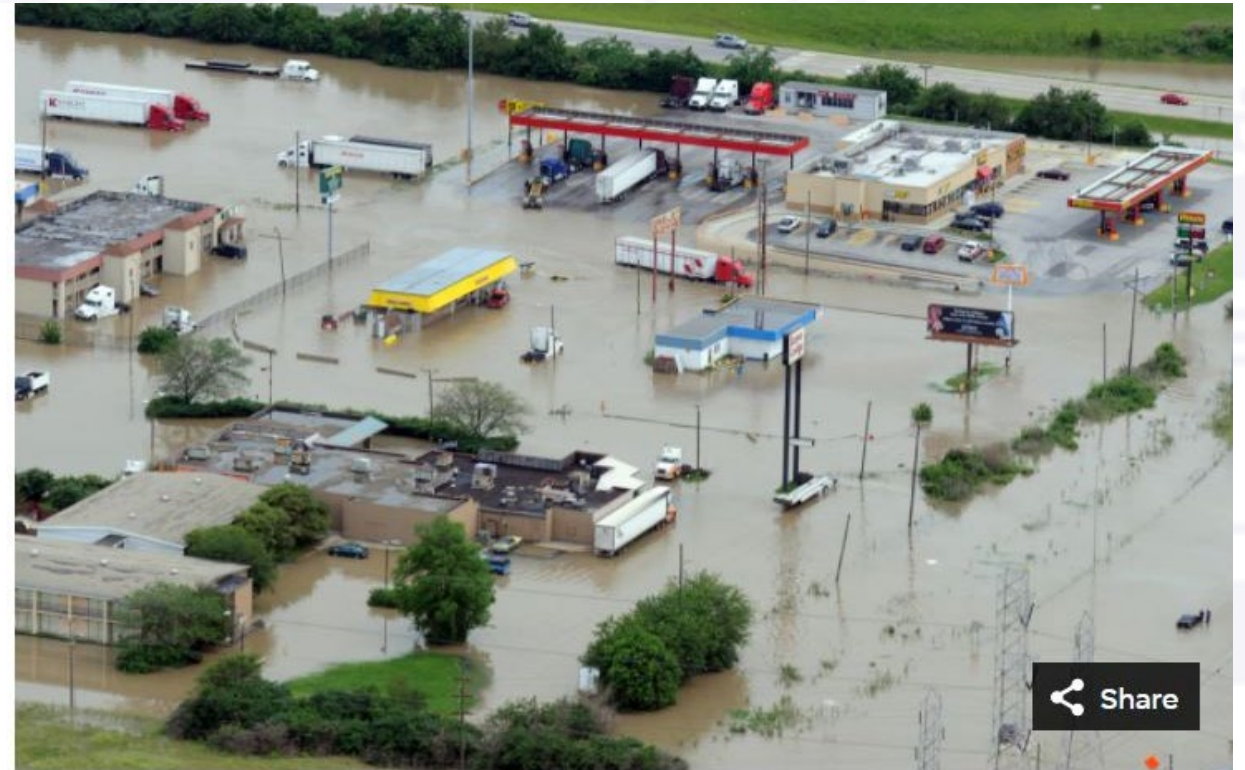
2008 flooding

Flood waters rise around the businesses at the Pilot Truck stop at south Harding Street just north of I-465 Saturday afternoon on the southwest side of Indianapolis. (from WTHR Chopper 13)

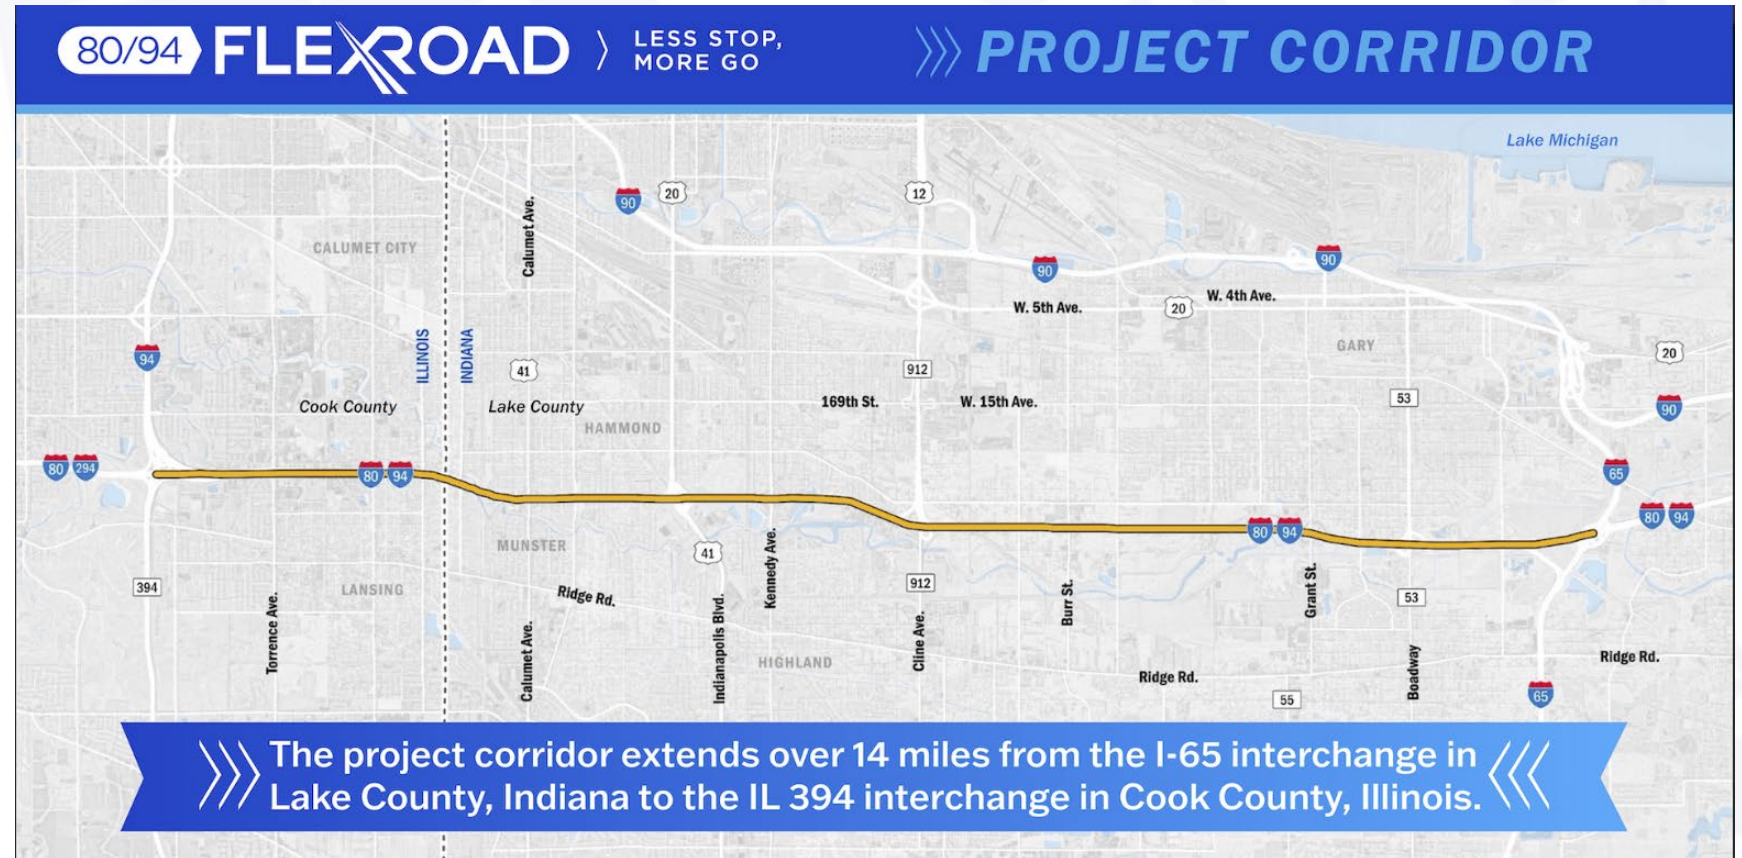
- Need for additional lane due to high traffic
- Proposed using median shoulder as travel lane

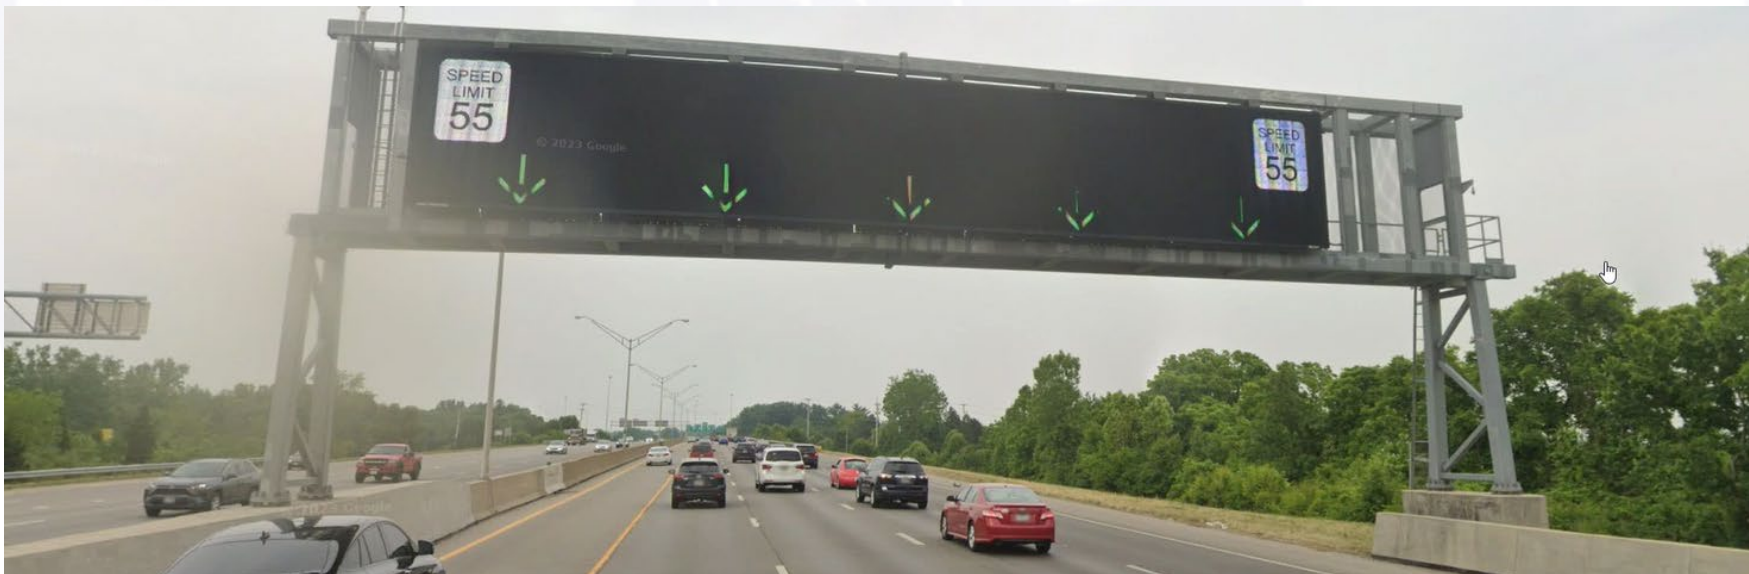
- Solution
 - Designer proposed over head signals to close the lane when there is rain event

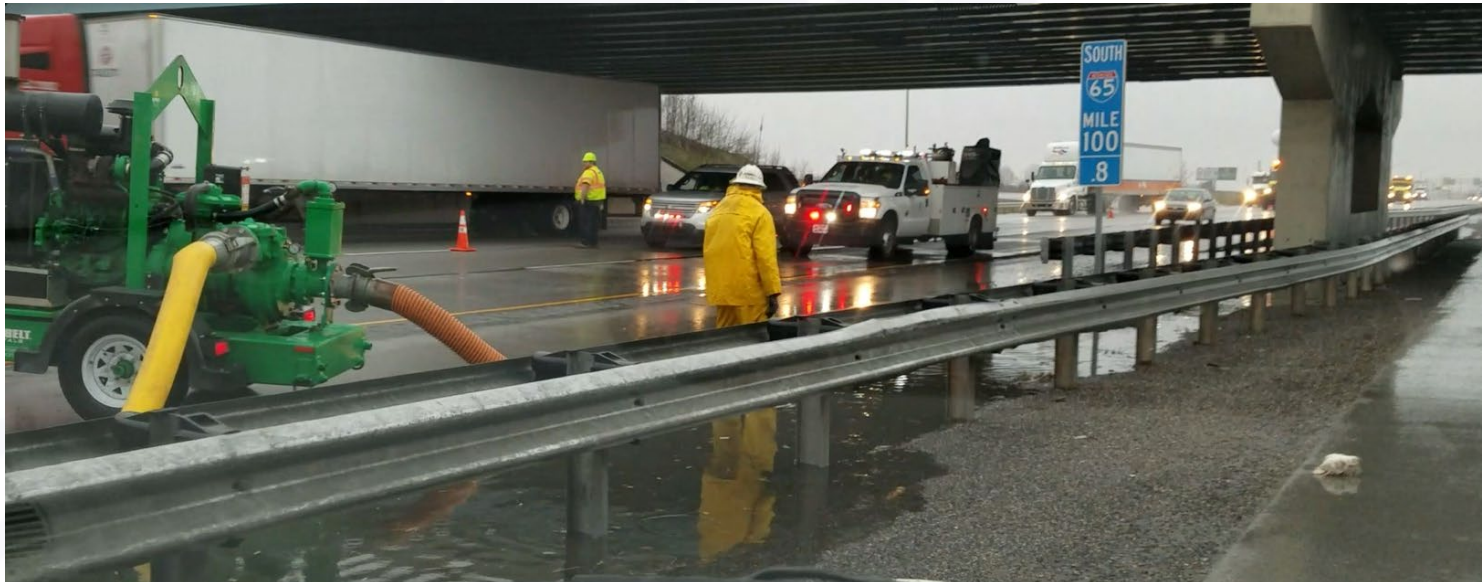
- Area 2 – County Line Road
 - Added travel lanes
 - New lanes to inside
 - Designer analyzed the median drains but
 - Median drains drained to an infield
 - Downstream culvert headwater impacted the performance of the median drains

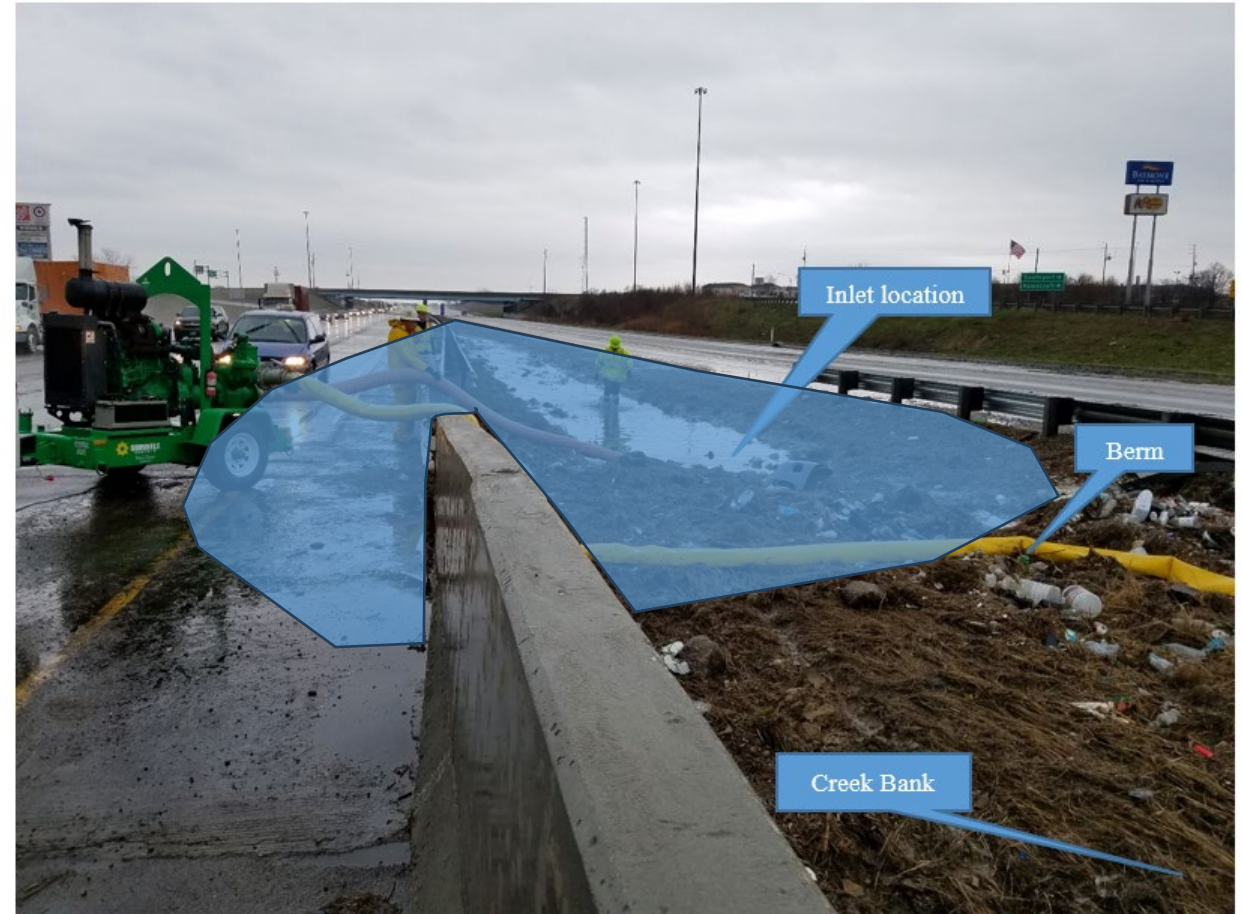
Bridge over Little Buck Creek

- The median drain clogged
- Berm was higher than the edge of lane
- Water backed up into the lane

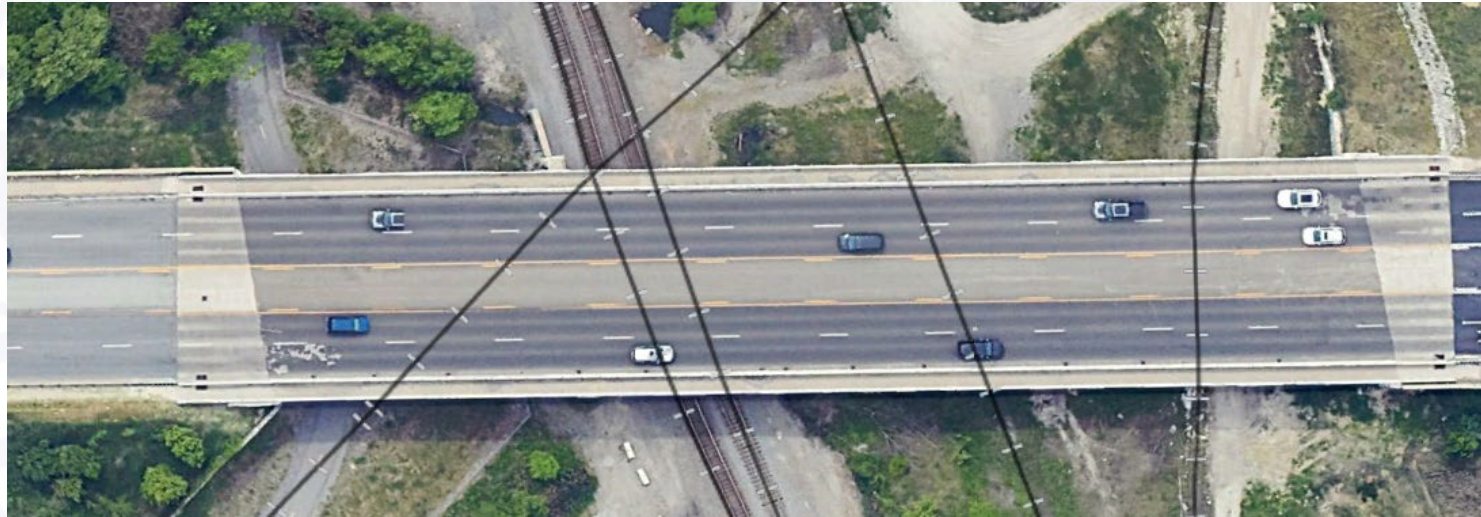
- INDOT and Railroad concerned with maintenance old deck drains

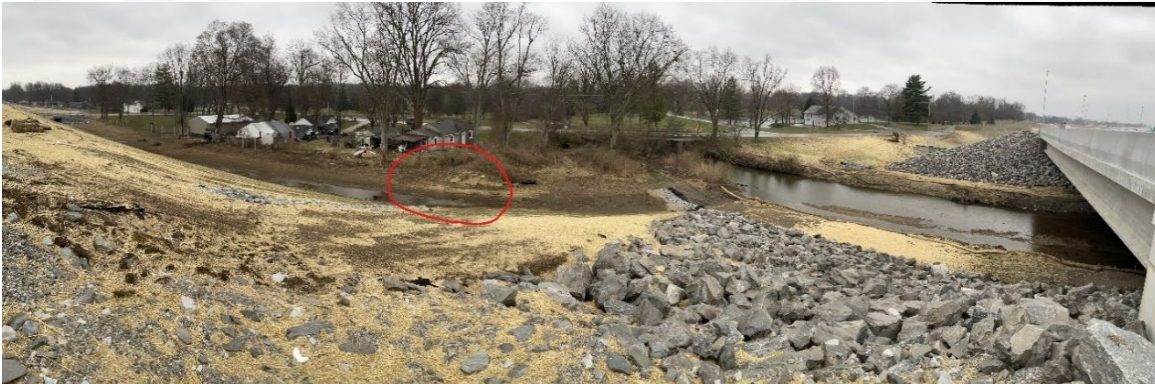
- Survey did not identify existing berm
 - Berm and low flow pipe removed
- It appeared to be protecting a small subdivision from small storm floods
- Construction contacted hydraulics
