Pavement Condition Report

Madison Municipal Airport

Project 16801839

January 2016

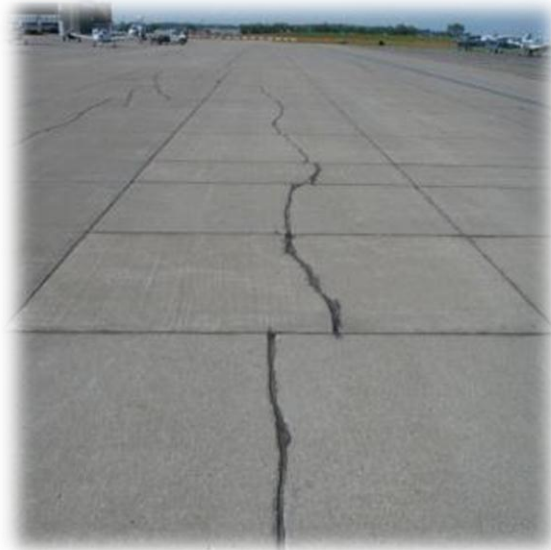
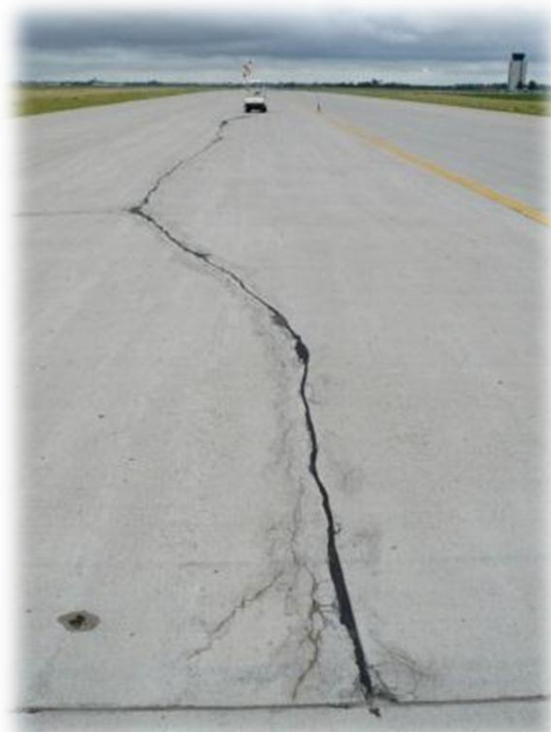
At low severity, a crack is less than 1/8 inch wide with little spalling, and no corrective action is indicated. At medium severity, LTD cracks can be up to 1 inch wide with moderate spalling and should be repaired using procedures similar to joint sealing. At high severity, cracks exceed 1 inch in width and may be severely spalled. High-severity LTD cracking is evidence of serious load failure, and correction may require patching or slab replacement. If distress occurs in several adjacent slabs at medium or high severity, major rehabilitation of that area is indicated.

A slab divided into four or more pieces is said to be “divided” or “shattered.” Shattered slab is a separate distress category and indicates a significant structural failure. A shattered slab has lost its ability to distribute loads. Shattered slabs are rated in three severities, but the recommended action in any case is slab replacement.

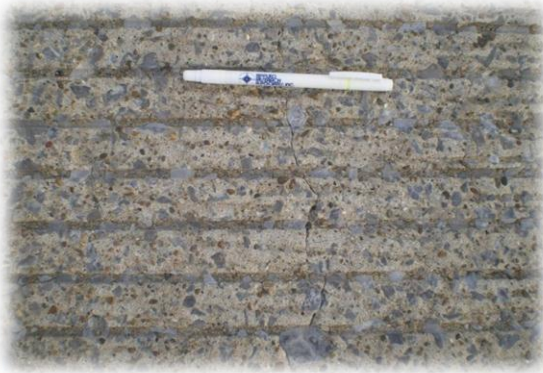
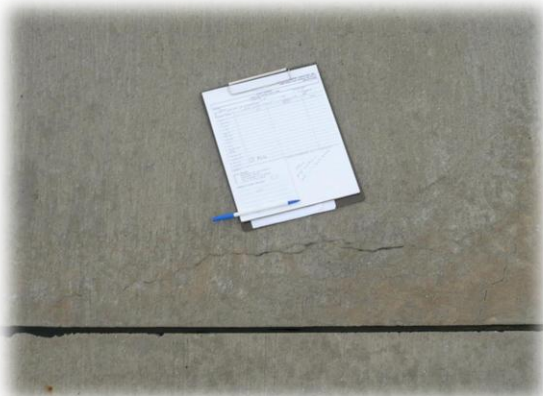
Shrinkage Cracking

Shrinkage cracks are small, non-working cracks visible at the pavement surface but not penetrating the full depth of concrete. Shrinkage cracks most commonly occur shortly after construction due to concrete shrinkage during the curing process.

Shrinkage cracks are usually so small that they are not visible until staining or loss of material at crack edges begins to take place. Shrinkage cracks do not represent structural weakness, and no corrective action is prescribed.

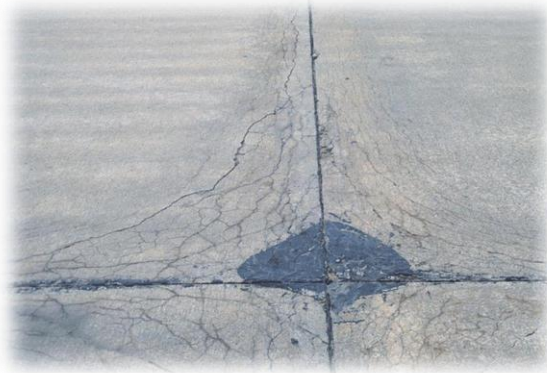
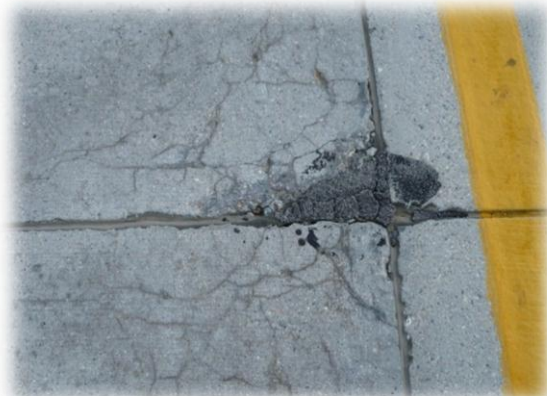
Durability Cracking

Durability cracking (D-cracking) is caused by environmental factors, the most common being freeze/thaw. D-cracking usually appears as either a pattern of hairline cracks running parallel to a joint or crack, or in a corner, where water tends to collect. D-cracking eventually leads to disintegration of the pavement, creating foreign object damage (FOD) potential.

At low severity, D-cracking is evident, but no disintegration has occurred. Medium severity is evident over a significant area of the slab, and some disintegration and FOD potential exist. High-severity D-cracking is evidenced by extensive cracking with loose and missing pieces and significant FOD potential.

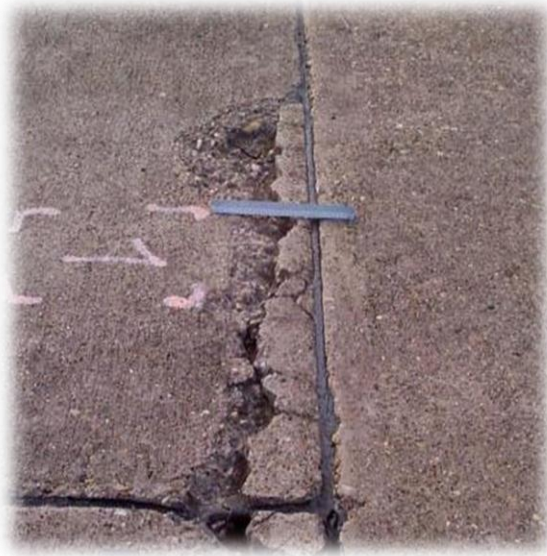
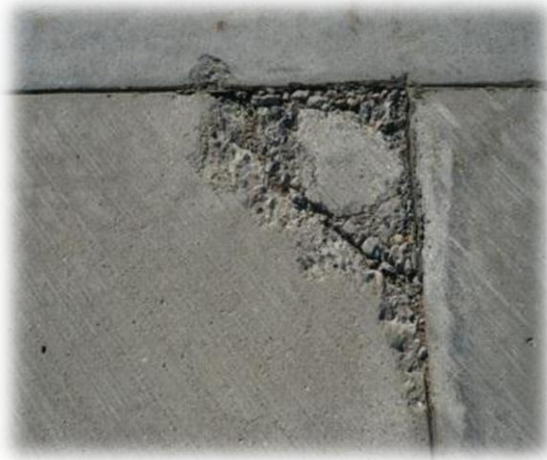
Joint Spall and Corner Spall

Spalls at slab joints and corners are caused by excessive internal stress in the pavement. Spalls occur when these stresses exceed the shear strength of the concrete.

Spalling usually results from thermal expansion during hot weather when slabs push and expand against one another. If the joints are filled with incompressible material, such as sand, stresses can become severe, causing spalls. Spalling can be reduced significantly by maintenance of joint sealant.

Spall repair requires patching. The extent and severity of spalling suggests the appropriate action. At low severity, spalled concrete remains securely in place in the slab. A low-severity spall should be monitored closely for further deterioration and should be patched when spalled particles become loose, or during the next scheduled patching activity. Medium- and high-severity spalls should be repaired immediately to prevent FOD. If the pavement can be restored to serviceable condition, spalls should be patched for long-term service. If the pavement is beyond repair, temporary patching should be considered to control FOD.

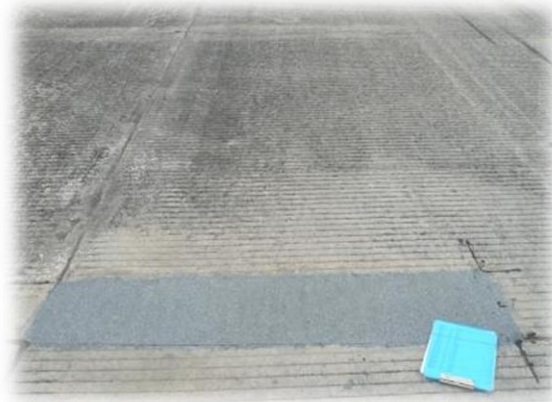
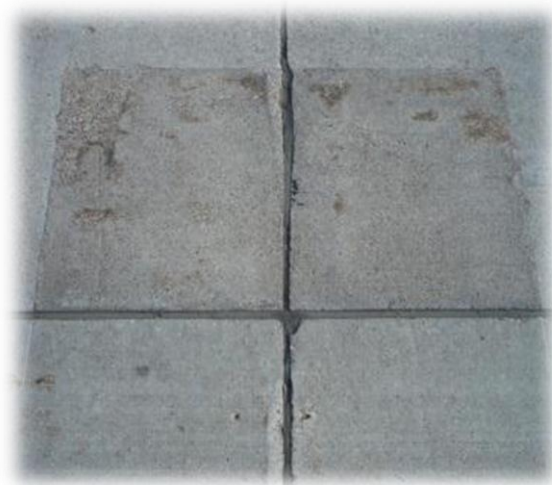
Patches, Large and Small

Large and small patches, by PCI inspection criteria, are distress conditions. Patches indicate deterioration and aging of pavement that contributes to shortened service life. However, patching also indicates that pavement is being maintained.

A patch that is performing well and shows no outward distress is recorded at low severity, and no corrective action is required. Medium-severity patches are serviceable but are beginning to deteriorate. Maintenance or replacement is indicated. At high severity, replacement is indicated.

By definition, small patches are smaller than 5 square feet in surface area, and they usually result from spall repair at slab joints and corners.

Large patches also may be the result of spall repair, but they often indicate more serious deficiencies, such as corner breaks or other full-depth failure smaller than panel size.

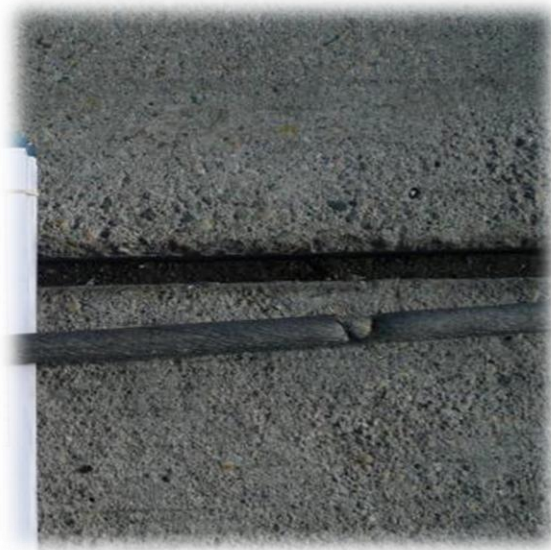
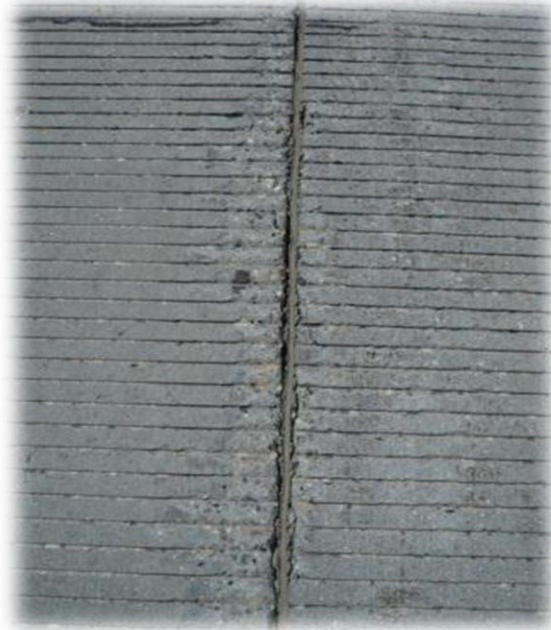
Joint Seal Damage

When joint sealant is in perfect condition (no damage), there is no distress.

At low severity, at least 10 percent of the sealant is debonded but still in contact with the joint edges. Medium-severity joint seal damage is recorded when at least 10 percent of the sealant has visible gaps smaller than 1/8 inch and is an indicator that replacement should be programmed as soon as is practical. In the meantime, aggressive inspection and sustaining maintenance is recommended to minimize subsurface damage from moisture penetration. At high severity, visible gaps exceed 1/8 inch, and the amount and degree of joint seal damage typically requires complete removal and replacement of the existing sealant.

On serviceable pavement, deteriorated joint sealant should be repaired or replaced to preserve pavement and subgrade integrity and prolong service life. The issue is not so clear-cut with unserviceable pavement. Pavement that can be restored to serviceable condition by maintenance activities such as patching and joint seal repair, or by slab replacement, should be so maintained as long as the process is cost-effective. However, when age and condition preclude economical return to serviceable condition by such means, joint seal repair would no longer be cost-effective and should be suspended except for an interim maintenance program to control FOD potential.

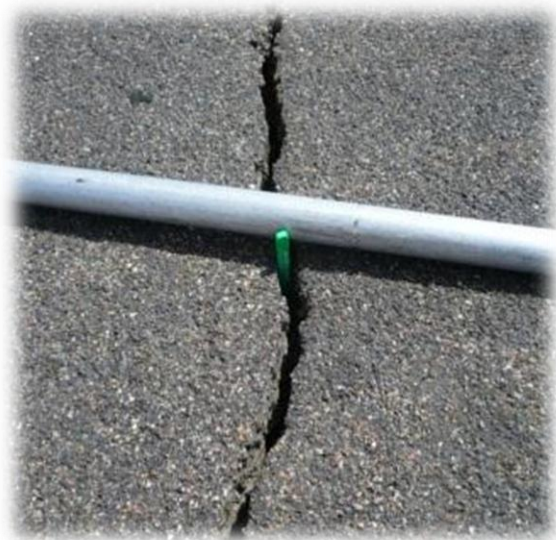
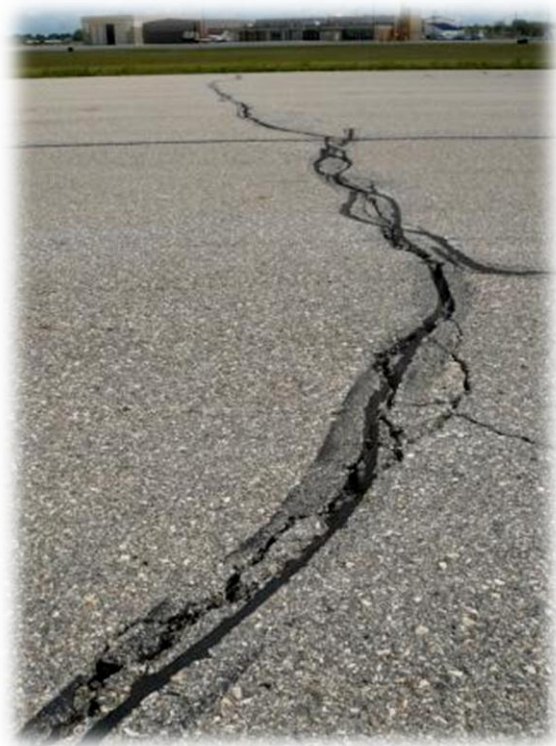
Longitudinal & Transverse Cracking

L&T cracks are caused by age, construction, and subsurface conditions. Age-related cracking occurs as oxidizing pavement loses components to the atmosphere and becomes more brittle. Consistent application of seal coats can help to prevent age-related cracks.

Construction-related cracking often develops along paving joints. Ensuring that joints are made when both sides are still hot, and near the same temperature, is one of the best ways to mitigate this potential problem.

Seasonal movement caused by changes in subsurface moisture or temperature differences also can cause pavement cracking. Asphalt pavement placed over a PCC pavement or cement stabilized base course may evidence reflective cracking from the underlying material. Wheel loads do not cause L&T cracks, although traffic may worsen their condition.

Low-severity L&T cracks are less than ¼ inch wide, or if sealed with suitable filler material in satisfactory condition can be any width less than 3 inches, if they are not spalled. Maintenance usually is not indicated for low-severity cracking. Moderately spalled cracks and cracks wider than ¼ inch which are not satisfactorily sealed are at medium severity. Medium-severity cracks should be sealed with a high-quality crack filling material. Severely spalled cracks and cracks wider than 3 inches are at high severity. High-severity L&T cracks normally require patching.

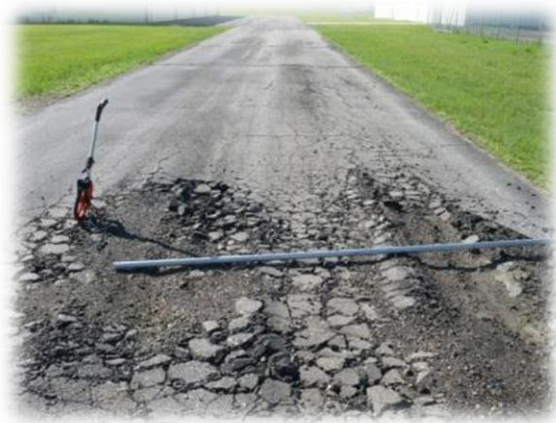
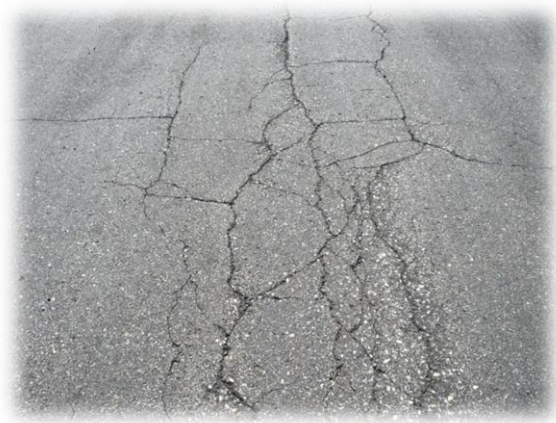
Alligator Cracking

Alligator cracks are a series of interconnected load-related cracks caused by fatigue of the asphalt surface. Alligator cracking is a significant structural distress and develops only in places subject to traffic loads. These cracks typically initiate at the bottom of the asphalt layer and propagate upward. Once a fatigue crack is visible at the surface, significant damage has already occurred.

At low severity, alligator cracks are evidenced by a series of parallel hairline cracks (usually in a wheel path). Medium-severity alligator cracking is a well-defined pattern of interconnected cracks, and some spalling may be present. High-severity alligator cracks have lost aggregate interlock between adjacent pieces, and the cracks may be severely spalled with FOD potential. Most likely, the pieces will move freely under traffic.

Alligator cracking is a serious structural failure that cannot be repaired with sealant. The proper repair is patching.

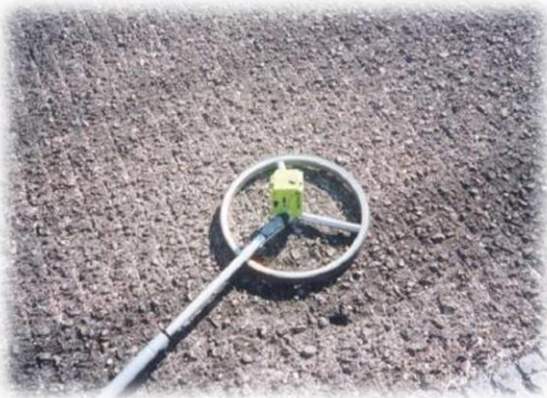
Raveling/Weathering

Raveling and weathering are the wearing away of the pavement surface. Failure can be caused by the dislodging of aggregate particles or the loss of asphalt binder. These distresses are usually evident over large areas and may indicate that the asphalt binder has hardened significantly.

Raveling: At low severity, 5 to 20 coarse aggregate particles are missing per square yard. Medium severity is defined by 20 to 40 missing coarse aggregate particles per square yard. At high severity, more than 40 coarse aggregate particles are missing per square yard, and the top layer of aggregate has eroded away.

Weathering: At low severity, edges of coarse aggregate are exposed less than 1 mm. At medium severity, loss of fine aggregate is noticeable and edges of coarse aggregate are exposed up to 6 mm (1/4 inch). High severity weathering has edges of coarse aggregate exposed > 6 mm, with considerable loss of fine aggregate matrix and potential for loss of coarse aggregate.

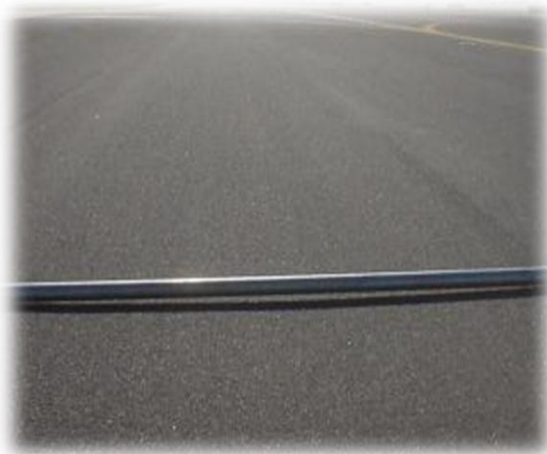
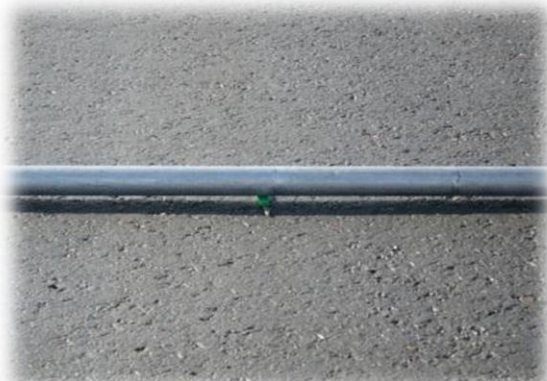
Ruts are localized areas of pavement having elevations lower than the surrounding sections.

Rutting is due to base and subgrade consolidation caused by excessive wheel loads or poor compaction. Ruts indicate structural failure and can cause hydroplaning.

At low severity, ruts have an average depth of ¼ to ½ inches. At medium severity, ruts have an average depth of ½ to 1 inch. At high severity, ruts have an average depth greater than 1 inch. Patching is the appropriate repair for ruts.

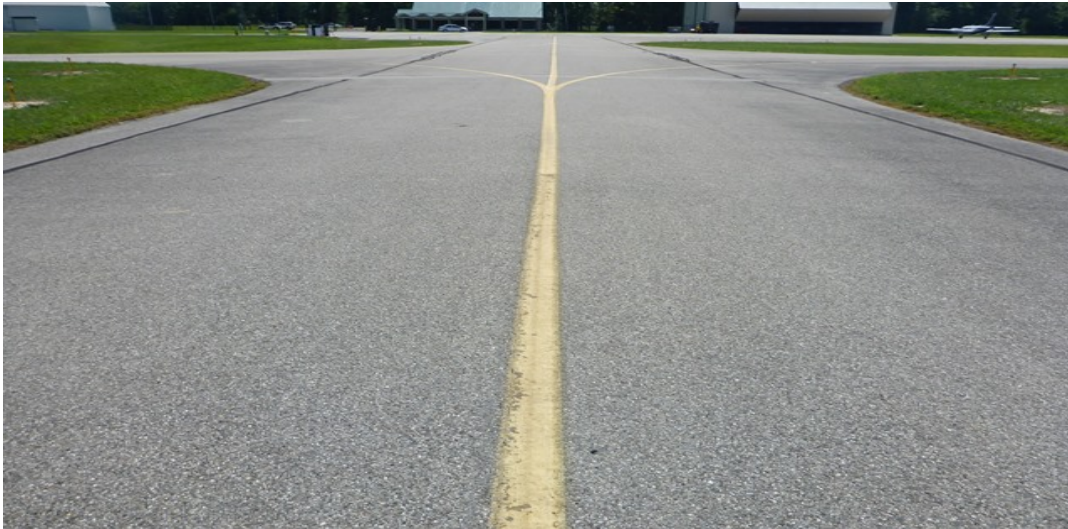
| DISTRESS TYPE | SEVERITY | MEASURED QUANTITY | ESTIMATED TOTAL QUANTITY | UNITS | PERCENTAGE OF All DISTRESS |
|---|---|---|---|---|---|
| ALLIGATOR CRACKING | LOW | 24 | 24 | S.F. | 15.7 |
| LONG.& TRANS. CRACK | HIGH | 47 | 48 | L.F. | 28 |
| LONG.& TRANS. CRACK | MED | 234 | 239 | L.F. | 31.6 |
| LONG.& TRANS. CRACK | LOW | 220 | 224 | L.F. | 14.5 |

| APPROXIMATE AMOUNT OF DISTRESS RELATED TO MATERIALS PROBLEMS IN THE FEATURE IS: | 53 % |
| APPROXIMATE AMOUNT OF DISTRESS RELATED TO AGE OF PAVEMENT AND TRAFFIC REPETITIONS IS: | 27 % |

| LEGEND | DESCRIPTION | COST | LIFE EXTENSION |
|---|---|---|---|
| ◆ | CRACK REPAIR | \$633 | 2 YEARS |

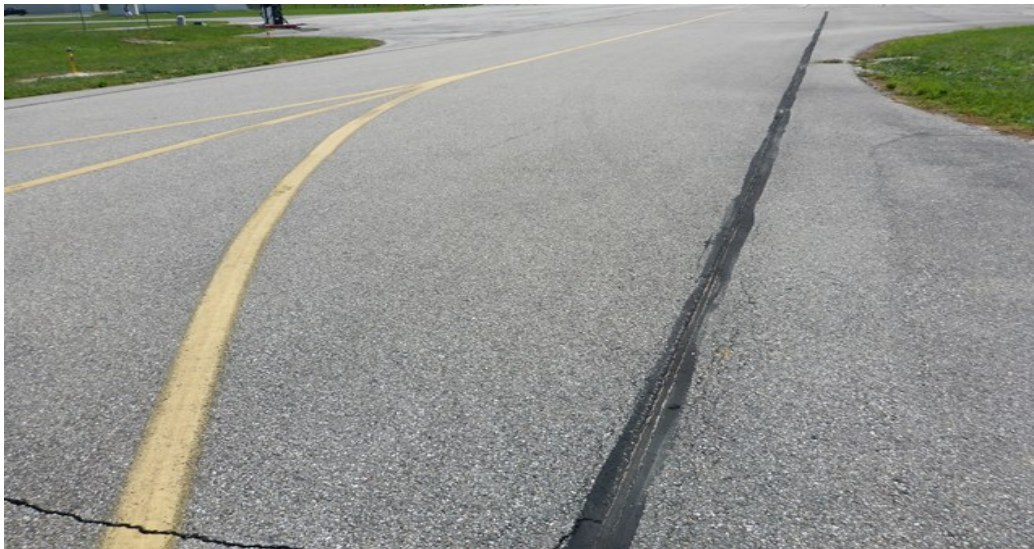
| DISTRESS TYPE | SEVERITY | MEASURED QUANTITY | ESTIMATED TOTAL QUANTITY | UNITS | PERCENTAGE OF All DISTRESS |
|---|---|---|---|---|---|
| ALLIGATOR CRACKING | LOW | 42 | 45 | S.F. | 32.3 |
| LONG.& TRANS. CRACK | HIGH | 64 | 68 | L.F. | 34.9 |
| LONG.& TRANS. CRACK | MED | 101 | 108 | L.F. | 22.7 |
| LONG.& TRANS. CRACK | LOW | 99 | 106 | L.F. | 9.9 |

| APPROXIMATE AMOUNT OF DISTRESS RELATED TO MATERIALS PROBLEMS IN THE FEATURE IS: | 45 % |
| APPROXIMATE AMOUNT OF DISTRESS RELATED TO AGE OF PAVEMENT AND TRAFFIC REPETITIONS IS: | 23 % |

| LEGEND | DESCRIPTION | COST | LIFE EXTENSION |
|---|---|---|---|
| ▼ | CRACK REPAIR | \$349 | 1 YEAR |

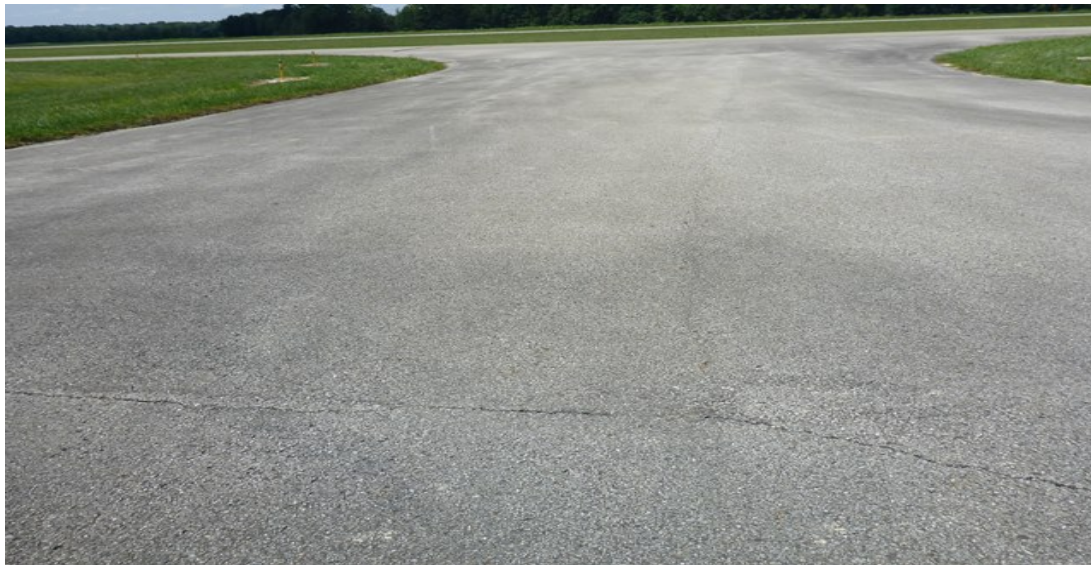
| DISTRESS TYPE | SEVERITY | MEASURED QUANTITY | ESTIMATED TOTAL QUANTITY | UNITS | PERCENTAGE OF All DISTRESS |
|---|---|---|---|---|---|
| LONG.& TRANS. CRACK | MED | 138 | 170 | L.F. | 51.3 |
| LONG.& TRANS. CRACK | LOW | 153 | 188 | L.F. | 27.4 |

| APPROXIMATE AMOUNT OF DISTRESS RELATED TO MATERIALS PROBLEMS IN THE FEATURE IS: | 70 % |
| APPROXIMATE AMOUNT OF DISTRESS RELATED TO AGE OF PAVEMENT AND TRAFFIC REPETITIONS IS: | 30 % |

| LEGEND | DESCRIPTION | COST | LIFE EXTENSION |
|---|---|---|---|
| ◆ | CRACK REPAIR | \$443 | 1 YEAR |

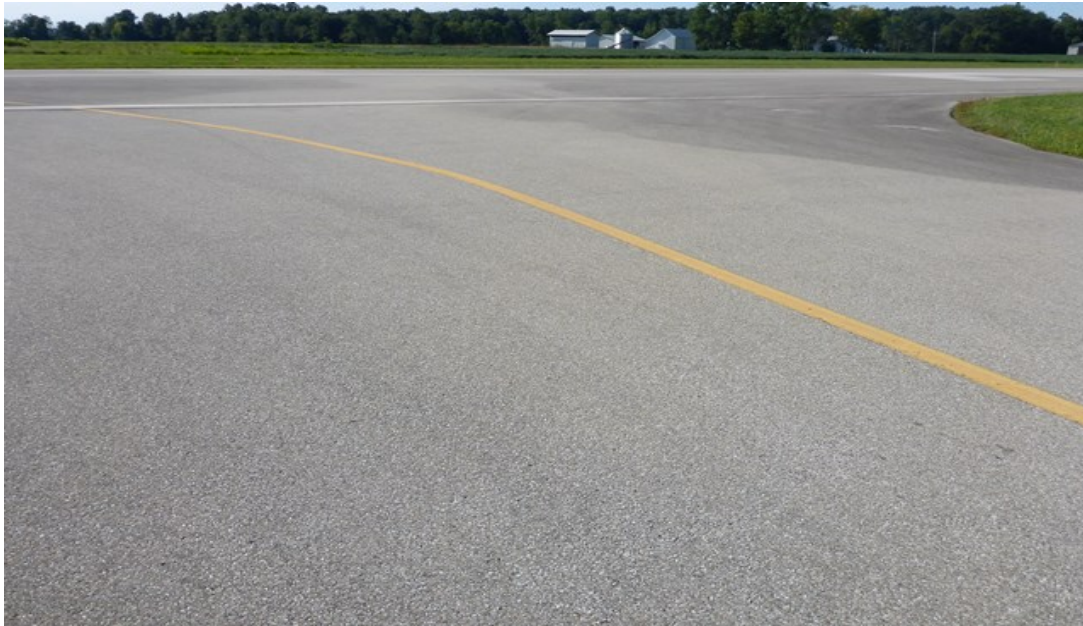
| DISTRESS TYPE | SEVERITY | MEASURED QUANTITY | ESTIMATED TOTAL QUANTITY | UNITS | PERCENTAGE OF All DISTRESS |
|---|---|---|---|---|---|
| LONG.& TRANS. CRACK | MED | 55 | 56 | L.F. | 58.6 |
| LONG.& TRANS. CRACK | LOW | 117 | 120 | L.F. | 41.3 |

APPROXIMATE AMOUNT OF DISTRESS RELATED TO LOAD ON THE PAVEMENT IS: 0 %
 APPROXIMATE AMOUNT OF DISTRESS RELATED TO MATERIALS PROBLEMS IN THE FEATURE IS: 67 %
 APPROXIMATE AMOUNT OF DISTRESS RELATED TO AGE OF PAVEMENT AND TRAFFIC REPETITIONS IS: 33 %

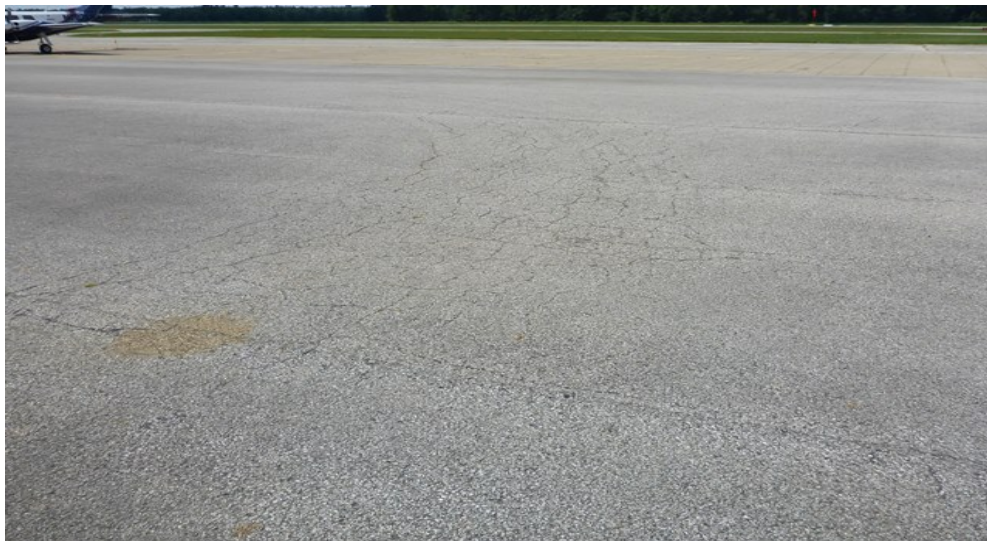
| DISTRESS TYPE | SEVERITY | MEASURED QUANTITY | ESTIMATED TOTAL QUANTITY | UNITS | PERCENTAGE OF All DISTRESS |
|---|---|---|---|---|---|
| ALLIGATOR CRACKING | LOW | 20 | 35 | S.F. | 4 |
| ALLIGATOR CRACKING | MED | 287 | 343 | S.F. | 16.7 |
| LONG.& TRANS. CRACK | LOW | 1,521 | 3,571 | L.F. | 23.9 |
| LONG.& TRANS. CRACK | MED | 947 | 2,083 | L.F. | 29.1 |
| LONG.& TRANS. CRACK | HIGH | 3 | 7 | L.F. | 2.1 |

APPROXIMATE AMOUNT OF DISTRESS RELATED TO LOAD ON THE PAVEMENT IS: 27 %
 APPROXIMATE AMOUNT OF DISTRESS RELATED TO MATERIALS PROBLEMS IN THE FEATURE IS: 46 %
 APPROXIMATE AMOUNT OF DISTRESS RELATED TO AGE OF PAVEMENT AND TRAFFIC REPETITIONS IS: 27 %

| LEGEND | DESCRIPTION | COST | LIFE EXTENSION |
|---|---|---|---|
| ◆ | CRACK REPAIR | \$7,019 | 2 YEARS |

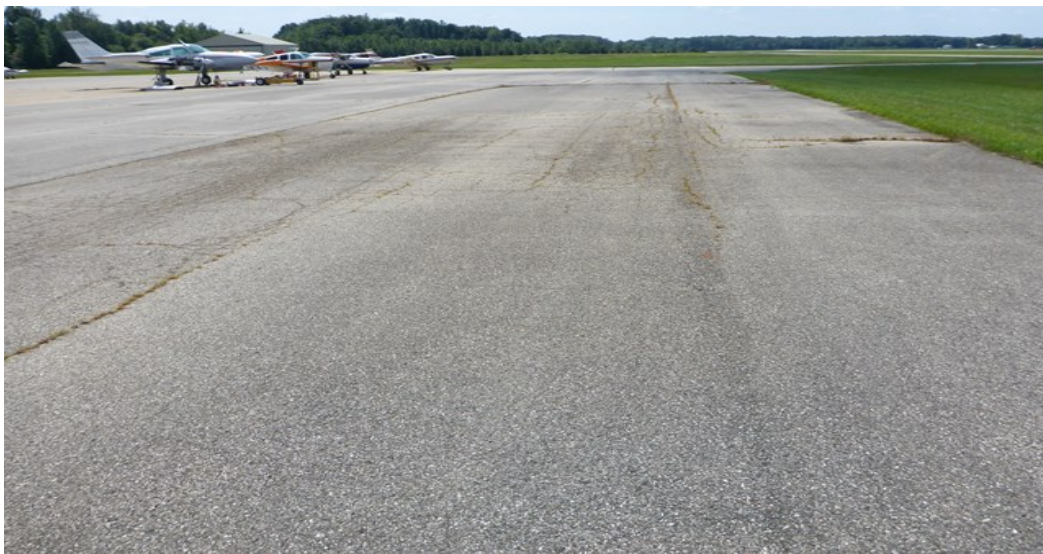
| DISTRESS TYPE | SEVERITY | MEASURED QUANTITY | ESTIMATED TOTAL QUANTITY | UNITS | PERCENTAGE OF All DISTRESS |
|---|---|---|---|---|---|
| ALLIGATOR CRACKING | HIGH | 80 | 185 | S.F. | 22.1 |
| ALLIGATOR CRACKING | MED | 455 | 1,057 | S.F. | 51.7 |
| LONG.& TRANS. CRACK | MED | 20 | 46 | L.F. | 6.6 |
| LONG.& TRANS. CRACK | LOW | 30 | 69 | L.F. | 4.2 |

| APPROXIMATE AMOUNT OF DISTRESS RELATED TO MATERIALS PROBLEMS IN THE FEATURE IS: | 13 % |
| APPROXIMATE AMOUNT OF DISTRESS RELATED TO AGE OF PAVEMENT AND TRAFFIC REPETITIONS IS: | 13 % |

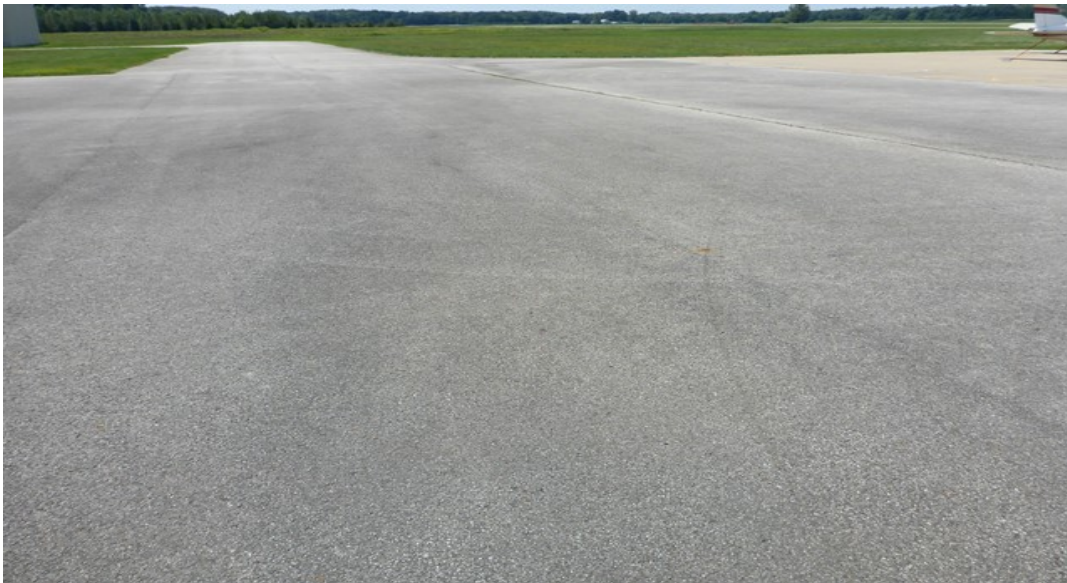
| DISTRESS TYPE | SEVERITY | MEASURED QUANTITY | ESTIMATED TOTAL QUANTITY | UNITS | PERCENTAGE OF All DISTRESS |
|---|---|---|---|---|---|
| LONG.& TRANS. CRACK | MED | 448 | 734 | L.F. | 61.3 |
| LONG.& TRANS. CRACK | LOW | 285 | 467 | L.F. | 23.3 |

| APPROXIMATE AMOUNT OF DISTRESS RELATED TO MATERIALS PROBLEMS IN THE FEATURE IS: | 62 % |
| APPROXIMATE AMOUNT OF DISTRESS RELATED TO AGE OF PAVEMENT AND TRAFFIC REPETITIONS IS: | 38 % |

| LEGEND | DESCRIPTION | COST | LIFE EXTENSION |
|---|---|---|---|
| ◆ | CRACK REPAIR | \$1,489 | 3 YEARS |

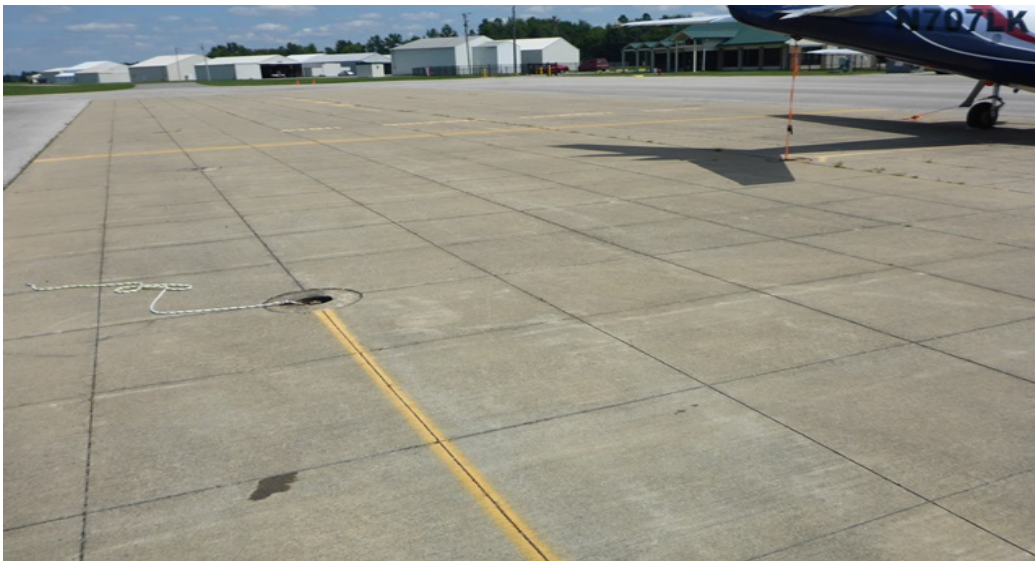
| DISTRESS TYPE | SEVERITY | MEASURED QUANTITY | ESTIMATED TOTAL QUANTITY | UNITS | PERCENTAGE OF All DISTRESS |
|---|---|---|---|---|---|
| SPALLING-JOINTS | LOW | 2 | 10 | SLABS | 1.2 |
| SPALLING-JOINTS | MED | 2 | 10 | SLABS | 2.7 |
| SPALLING-CORNERS | MED | 1 | 5 | SLABS | 1.3 |

APPROXIMATE AMOUNT OF DISTRESS RELATED TO LOAD ON THE PAVEMENT IS: 58 %
 APPROXIMATE AMOUNT OF DISTRESS RELATED TO MATERIALS PROBLEMS IN THE FEATURE IS: 24 %
 APPROXIMATE AMOUNT OF DISTRESS RELATED TO AGE OF PAVEMENT AND TRAFFIC REPETITIONS IS: 18 %

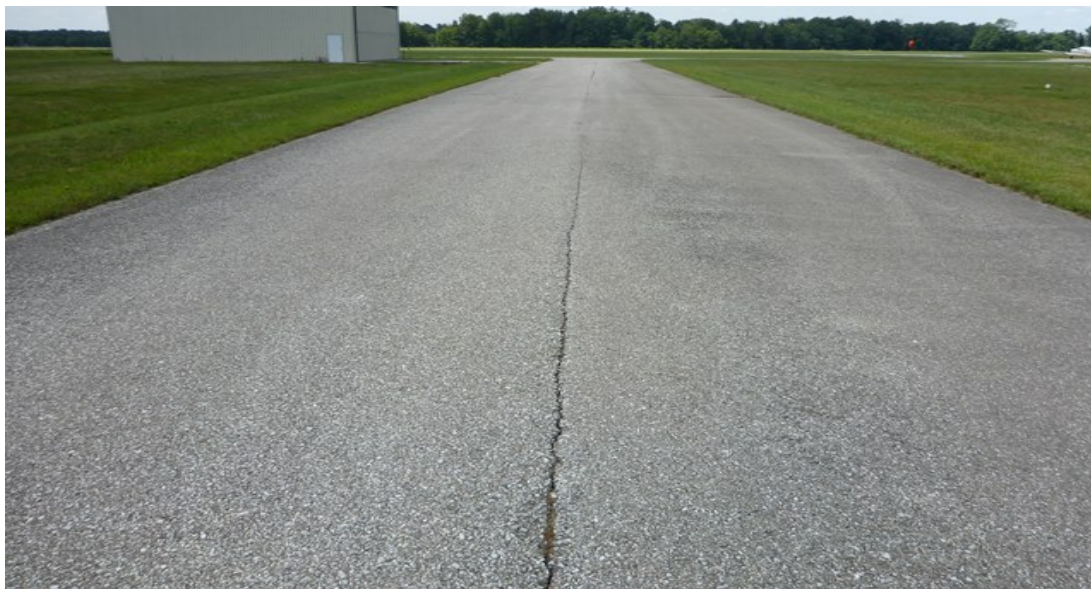
| DISTRESS TYPE | SEVERITY | MEASURED QUANTITY | ESTIMATED TOTAL QUANTITY | UNITS | PERCENTAGE OF All DISTRESS |
|---|---|---|---|---|---|
| LONG.& TRANS. CRACK | MED | 159 | 339 | L.F. | 54.2 |
| LONG.& TRANS. CRACK | LOW | 233 | 496 | L.F. | 31.4 |

| APPROXIMATE AMOUNT OF DISTRESS RELATED TO MATERIALS PROBLEMS IN THE FEATURE IS: | 62 % |
| APPROXIMATE AMOUNT OF DISTRESS RELATED TO AGE OF PAVEMENT AND TRAFFIC REPETITIONS IS: | 38 % |

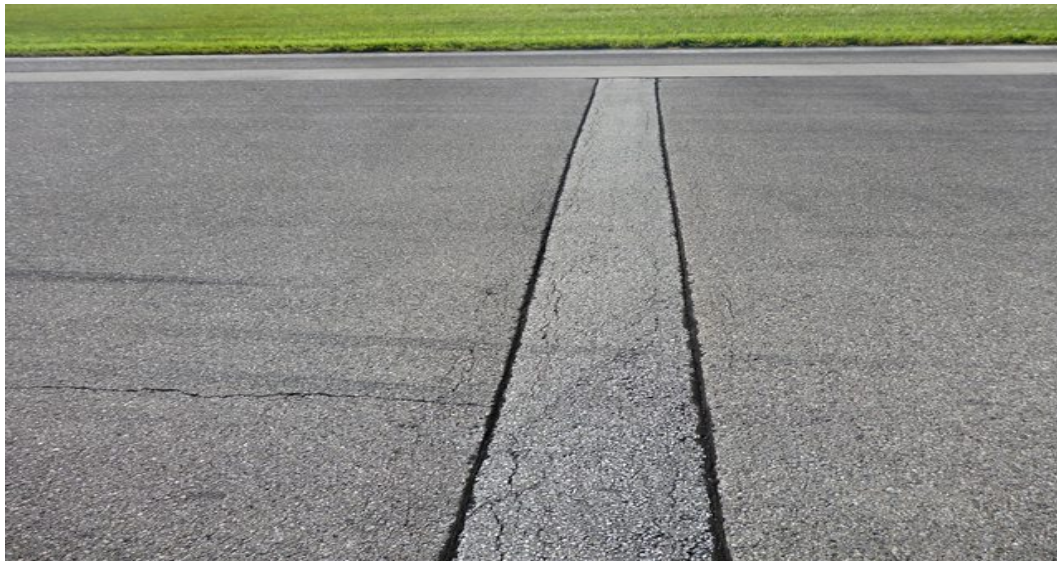
| DISTRESS TYPE | SEVERITY | MEASURED QUANTITY | ESTIMATED TOTAL QUANTITY | UNITS | PERCENTAGE OF All DISTRESS |
|---|---|---|---|---|---|
| ALLIGATOR CRACKING | LOW | 13 | 69 | S.F. | 3.5 |
| LONG.& TRANS. CRACK | HIGH | 1 | 5 | L.F. | 1.8 |
| LONG.& TRANS. CRACK | MED | 368 | 1,953 | L.F. | 25.6 |
| LONG.& TRANS. CRACK | LOW | 551 | 2,925 | L.F. | 15.5 |

| APPROXIMATE AMOUNT OF DISTRESS RELATED TO MATERIALS PROBLEMS IN THE FEATURE IS: | 46 % |
| APPROXIMATE AMOUNT OF DISTRESS RELATED TO AGE OF PAVEMENT AND TRAFFIC REPETITIONS IS: | 22 % |

| LEGEND | DESCRIPTION | COST | LIFE EXTENSION |
|---|---|---|---|
| ◆ | CRACK REPAIR | \$6,054 | 1 YEAR |

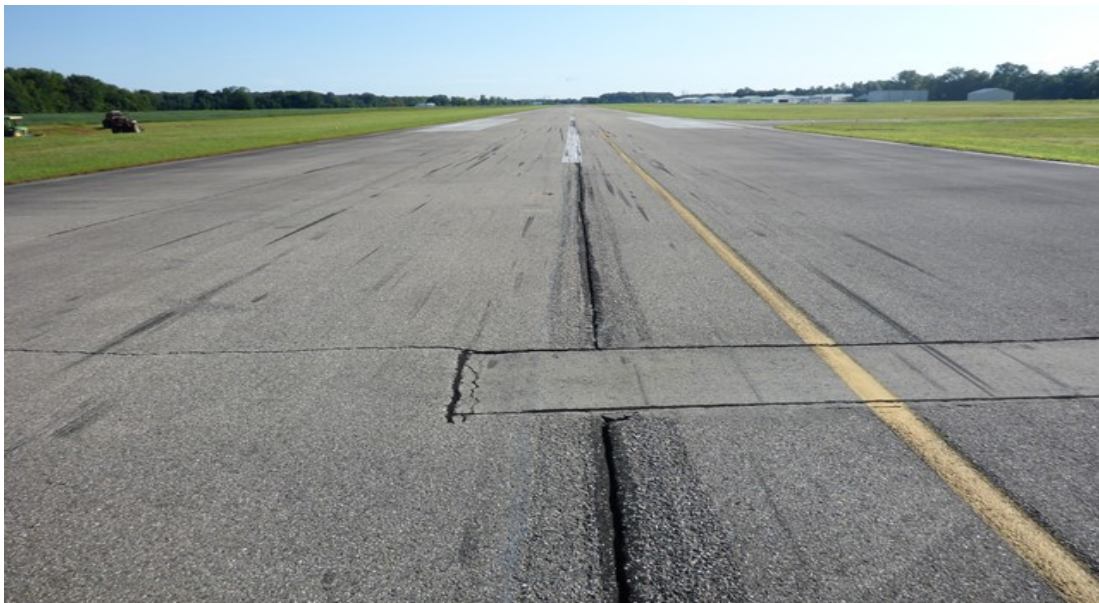
| DISTRESS TYPE | SEVERITY | MEASURED QUANTITY | ESTIMATED TOTAL QUANTITY | UNITS | PERCENTAGE OF All DISTRESS |
|---|---|---|---|---|---|
| LONG.& TRANS. CRACK | MED | 424 | 1,002 | L.F. | 51.2 |
| LONG.& TRANS. CRACK | LOW | 203 | 480 | L.F. | 14.6 |

| APPROXIMATE AMOUNT OF DISTRESS RELATED TO MATERIALS PROBLEMS IN THE FEATURE IS: | 55 % |
| APPROXIMATE AMOUNT OF DISTRESS RELATED TO AGE OF PAVEMENT AND TRAFFIC REPETITIONS IS: | 30 % |

| LEGEND | DESCRIPTION | COST | LIFE EXTENSION |
|---|---|---|---|
| ◆ | CRACK REPAIR | \$1,837 | 2 YEARS |

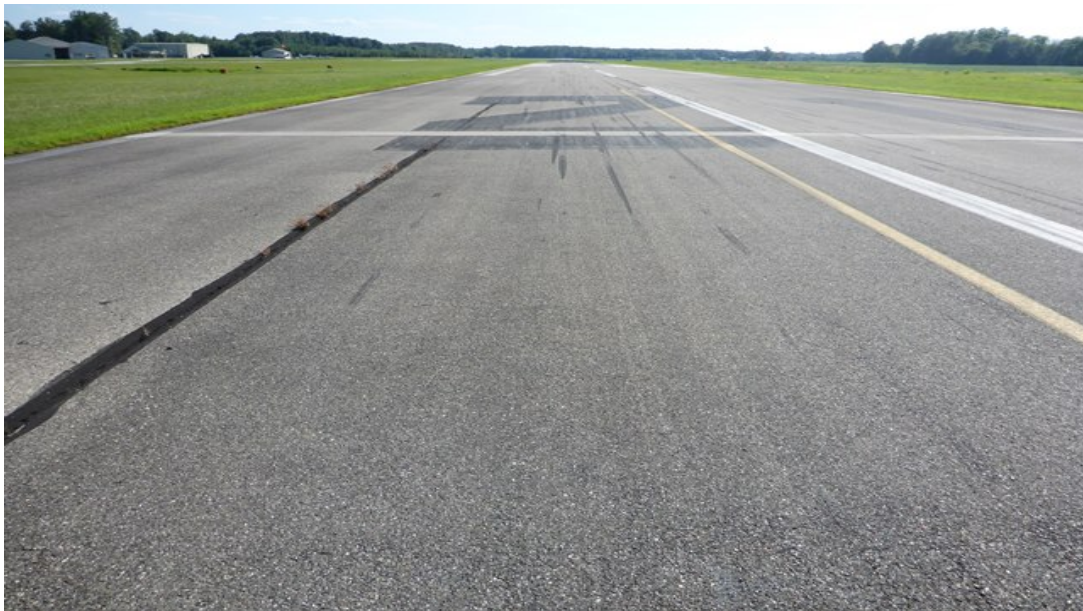
| DISTRESS TYPE | SEVERITY | MEASURED QUANTITY | ESTIMATED TOTAL QUANTITY | UNITS | PERCENTAGE OF All DISTRESS |
|---|---|---|---|---|---|
| LONG.& TRANS. CRACK | MED | 192 | 384 | L.F. | 47.4 |
| LONG.& TRANS. CRACK | LOW | 96 | 192 | L.F. | 14.5 |

| APPROXIMATE AMOUNT OF DISTRESS RELATED TO MATERIALS PROBLEMS IN THE FEATURE IS: | 54 % |
| APPROXIMATE AMOUNT OF DISTRESS RELATED TO AGE OF PAVEMENT AND TRAFFIC REPETITIONS IS: | 36 % |

| LEGEND | DESCRIPTION | COST | LIFE EXTENSION |
|---|---|---|---|
| ◆ | CRACK REPAIR | \$714 | 1 YEAR |

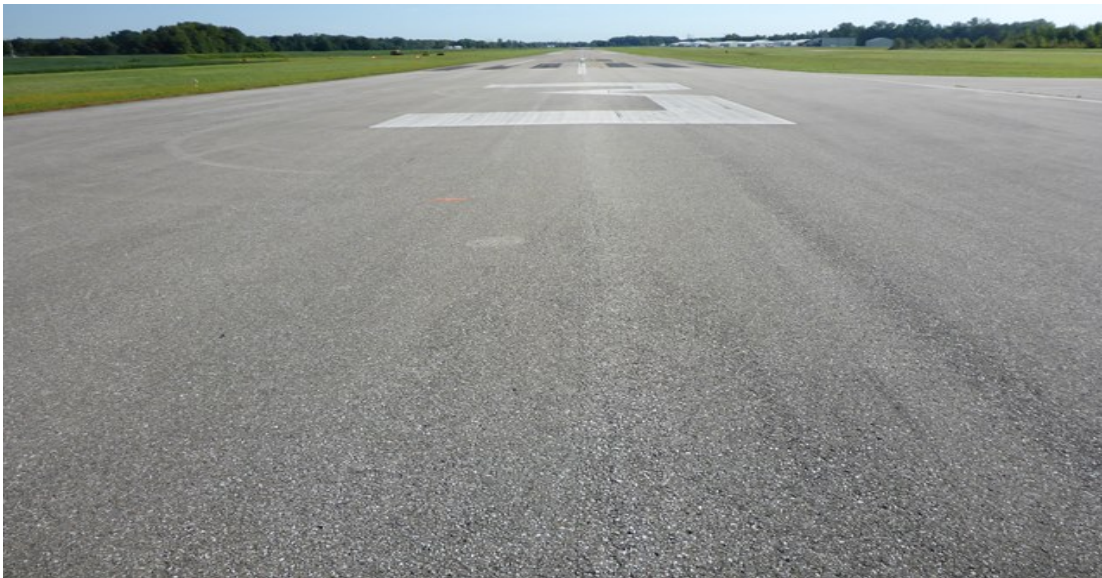
| DISTRESS TYPE | SEVERITY | MEASURED QUANTITY | ESTIMATED TOTAL QUANTITY | UNITS | PERCENTAGE OF All DISTRESS |
|---|---|---|---|---|---|
| LONG.& TRANS. CRACK | MED | 50 | 125 | L.F. | 67.6 |
| LONG.& TRANS. CRACK | LOW | 14 | 35 | L.F. | 24.9 |

| APPROXIMATE AMOUNT OF DISTRESS RELATED TO MATERIALS PROBLEMS IN THE FEATURE IS: | 64 % |
| APPROXIMATE AMOUNT OF DISTRESS RELATED TO AGE OF PAVEMENT AND TRAFFIC REPETITIONS IS: | 36 % |

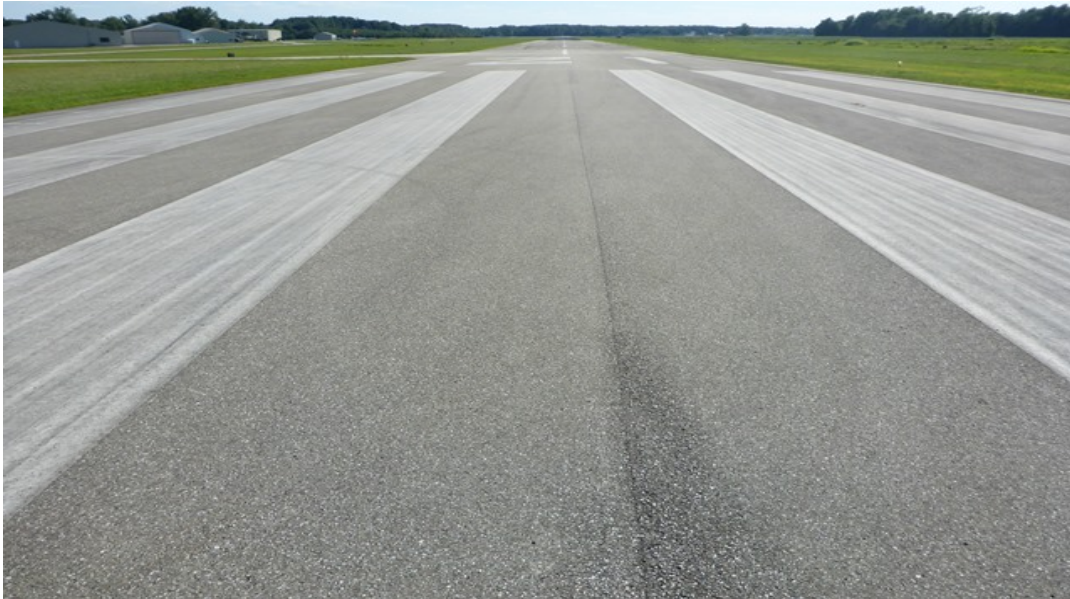
| DISTRESS TYPE | SEVERITY | MEASURED QUANTITY | ESTIMATED TOTAL QUANTITY | UNITS | PERCENTAGE OF All DISTRESS |
|---|---|---|---|---|---|
| LONG.& TRANS. CRACK | MED | 81 | 174 | L.F. | 30.3 |
| LONG.& TRANS. CRACK | LOW | 392 | 842 | L.F. | 67.4 |

| APPROXIMATE AMOUNT OF DISTRESS RELATED TO MATERIALS PROBLEMS IN THE FEATURE IS: | 66 % |
| APPROXIMATE AMOUNT OF DISTRESS RELATED TO AGE OF PAVEMENT AND TRAFFIC REPETITIONS IS: | 34 % |
